# **INDOOR AIR QUALITY ASSESSMENT**

**Department of Mental Health (DMH) Lindemann Building  
Central Office Mezzanine  
25 Staniford Street, Boston**

Prepared by:  
Massachusetts Department of Public Health  
Bureau of Environmental Health  
Indoor Air Quality Program  
October 2018

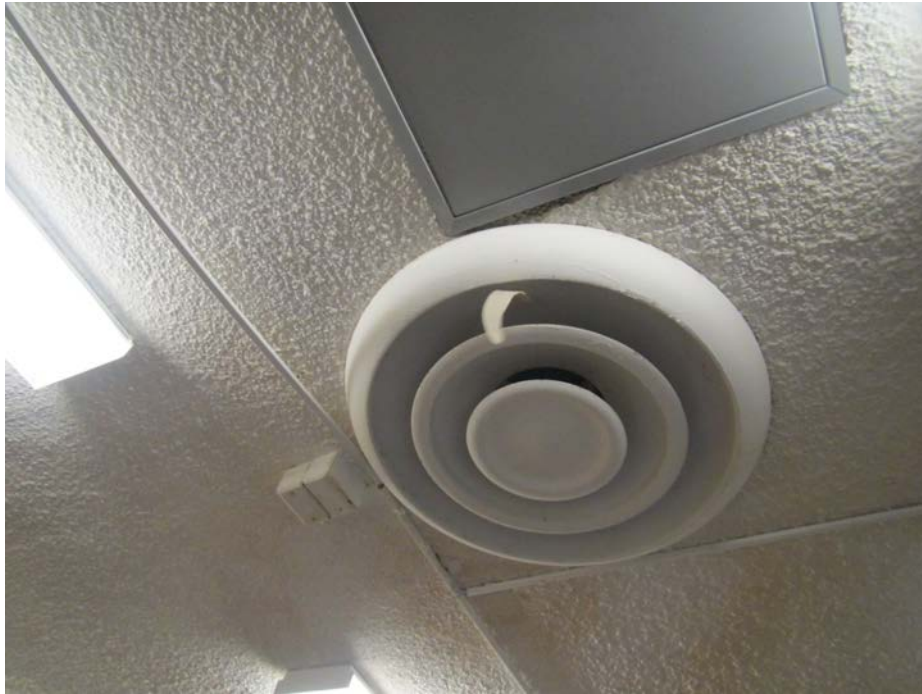
**Picture 1**

Fresh air is provided by air handling units (AHUs). Air from the AHUs is filtered, heated/cooled, and delivered to rooms via ducted supply vents (Pictures 1 and 2). Air is returned/exhausted through vents around lights (Picture 3). Additional heating is provided by radiators along outside edges of the building (Picture 4). In some rooms, it was difficult to identify if supply vents were present. Each room should have a source of fresh air. In some cases it appeared that fresh air was supplied in hallways outside offices and drawn into each office through the action of the return or exhaust vent. This may contribute to the distribution of odors, as discussed in the sections below. It could also not be determined if restroom vents were connected to the general return system or to a direct vented exhaust system. Direct exhaust venting in restrooms and other areas that generate odors and moisture is important to avoid recirculating them to the rest of the building.

**One style of supply vent**

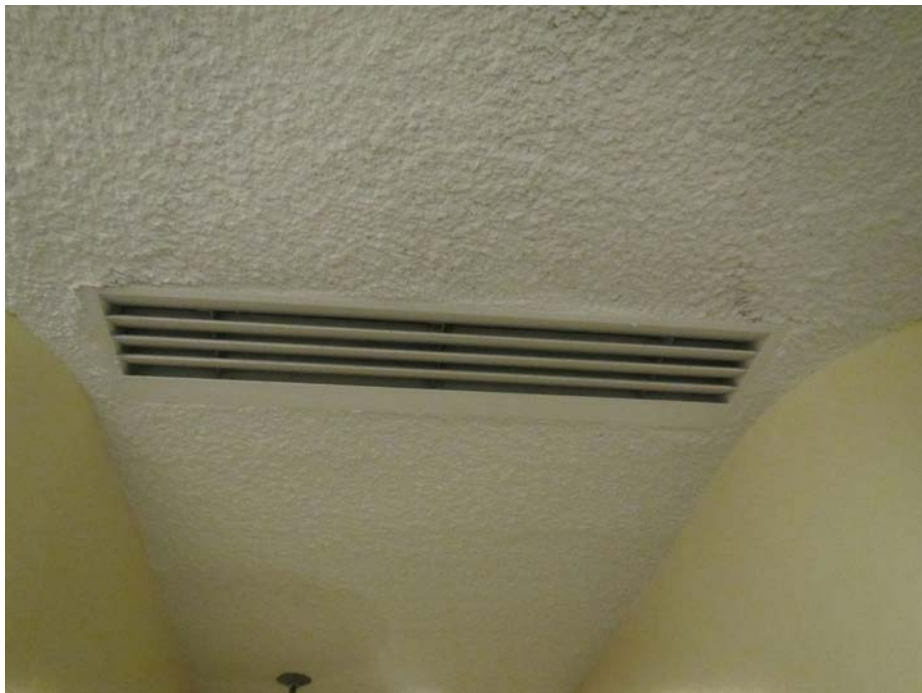
**Picture 2**

**Hallway supply vent**

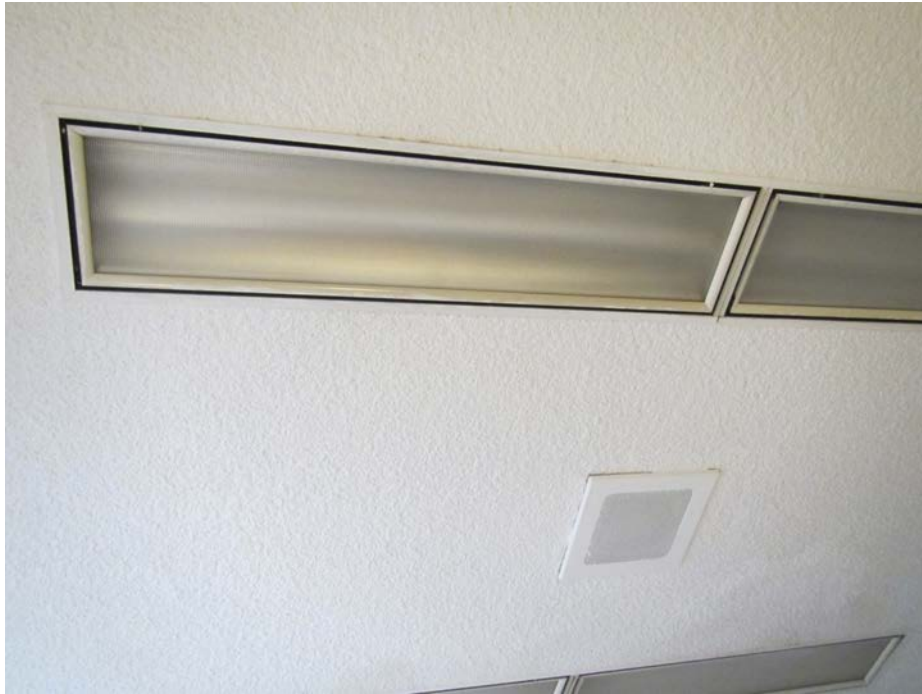
**Picture 3**

**Return vents around lights**

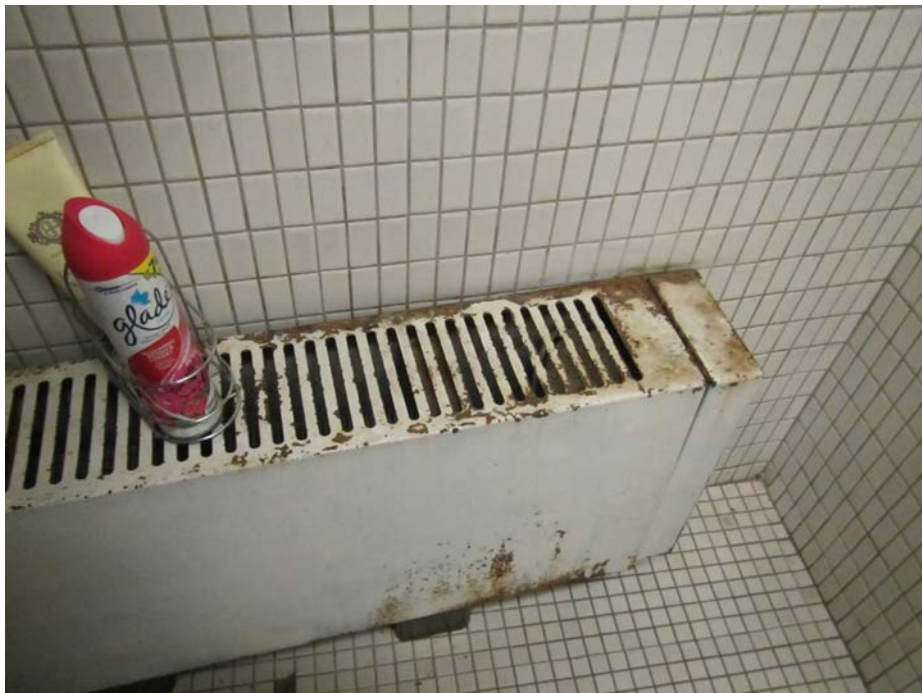
**Picture 4**

Many other signs of water damage were observed, including water-damaged ceiling plaster (Pictures 7 and 8), water-damaged paint, rust on radiators (Picture 4), water stains around windows and skylights (Picture 9) and signs of delaminated carpet. Some of these materials were damaged by infiltration through gaps in the building envelope. Other issues such as rust stains on radiators may be signs that high humidity from building envelope issues and lack of exhaust ventilation, especially in restrooms, has allowed water to condense on materials.

**Radiator in bathroom, note rust stains and cleaning products**

15. Use the services of a licensed pest contractor to assist with mice issues.
16. Clean dust and debris from ventilation equipment, including supply and exhaust vents, radiators and the blades of personal fans to prevent aerosolization of dust.

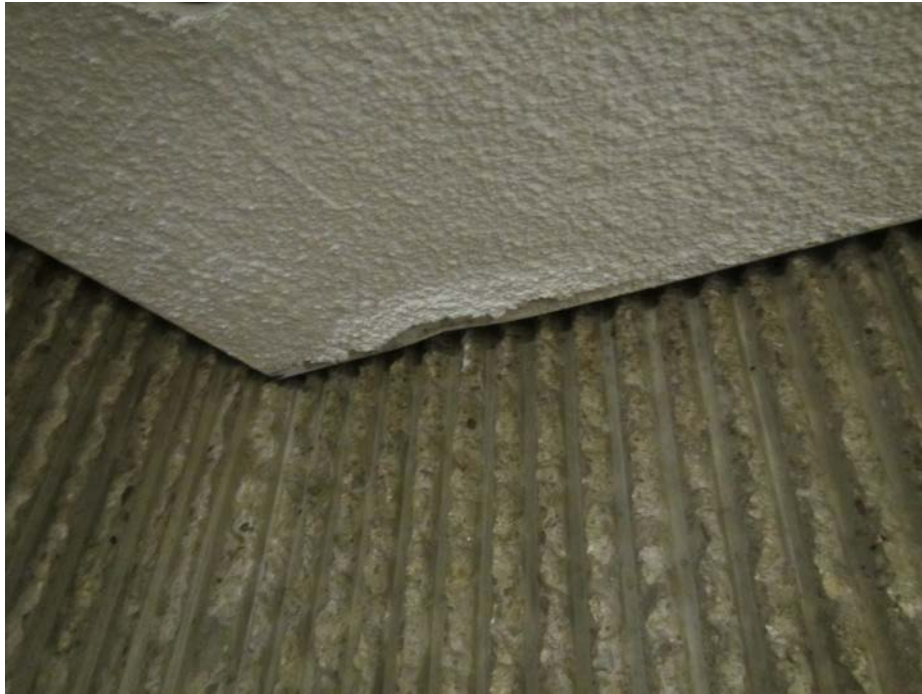
**Picture 5**

**Wall texture and damaged ceiling plaster**

4. Any carpeting or other porous materials that may have been moistened by blackwater should be removed and replaced.
5. Remediate areas of water-damaged building materials in accordance with the EPA guideline “Mold Remediation in Schools and Commercial Buildings” (US EPA, 2008). In areas with extensive damage and/or reported odors, the removal of wall and ceiling plaster may be required in order to assess and remediate hidden or internal damage. Clean non-porous water-stained surfaces, including walls and floors and remove any debris.

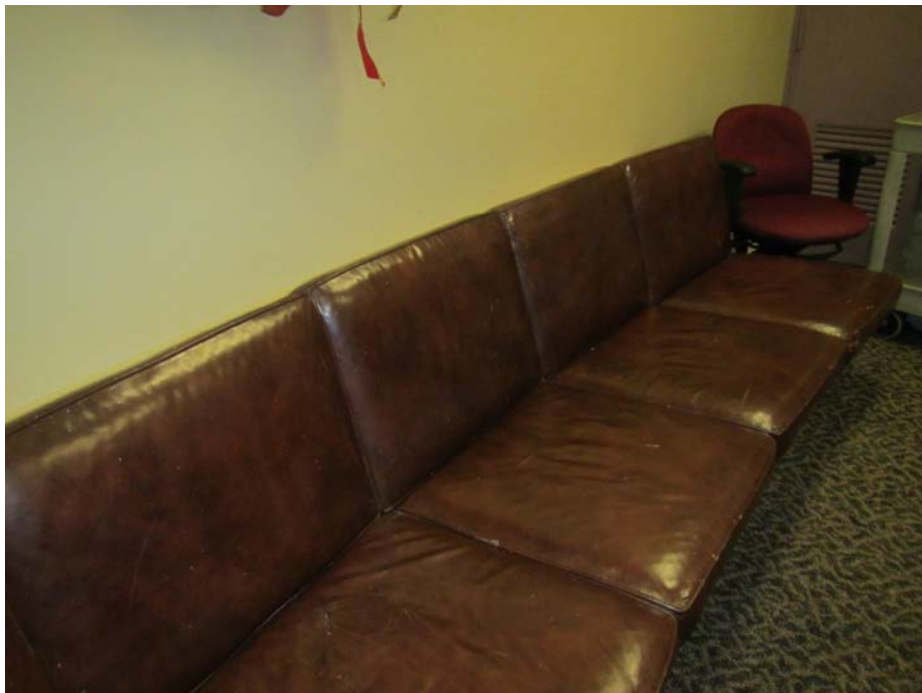
**Picture 6**

Although the specific odors that prompted this request were not detected at the time of the visit, one potential source may have been porous items, particularly carpeting, present in the employee entrance lobby. There are several carpets in this area as well as the leather couch shown in Picture 6. Note that there is a heating unit above the door that activates every time the door is opened. The airflow may contribute to the distribution of odors down the hallway. In addition, the action of exhaust/return vents in individual rooms may carry odors into offices.

**Leather couch in employee entrance lobby**

3. Ensure that carpeting that remains in the employee entrance lobby is odor free and cleaned frequently. Remove other porous materials in this area that show any signs of water damage or odors.

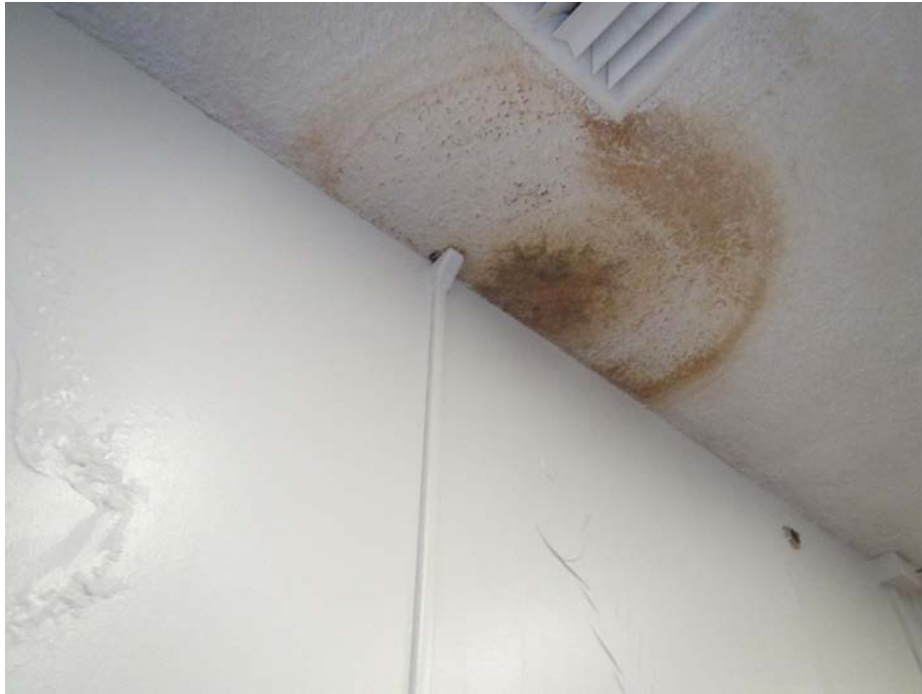
**Picture 7**

**Water-damaged ceiling plaster and paint**

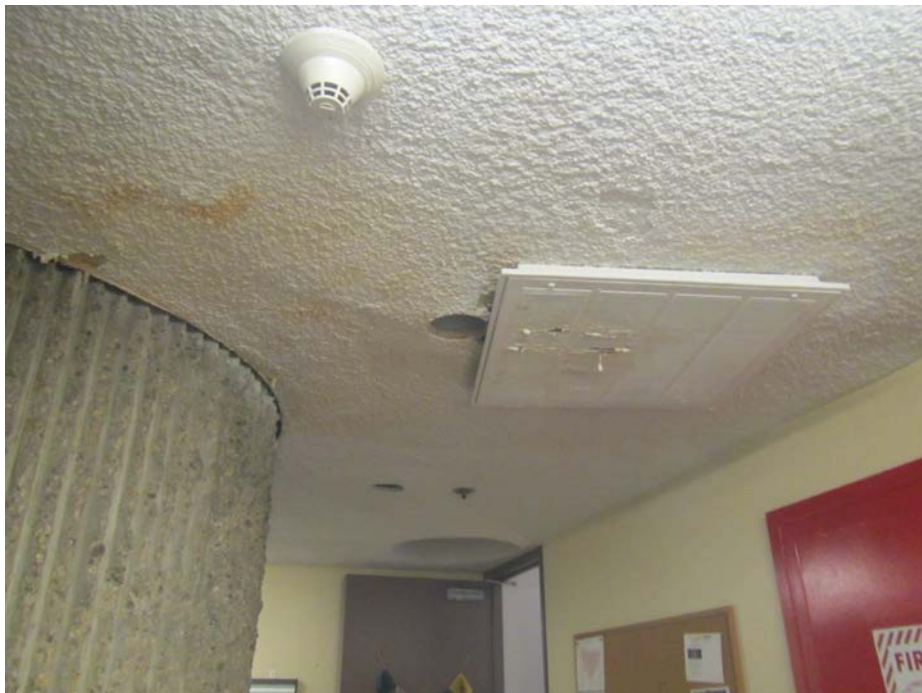
**Picture 8**

**Water-damaged ceiling plaster**

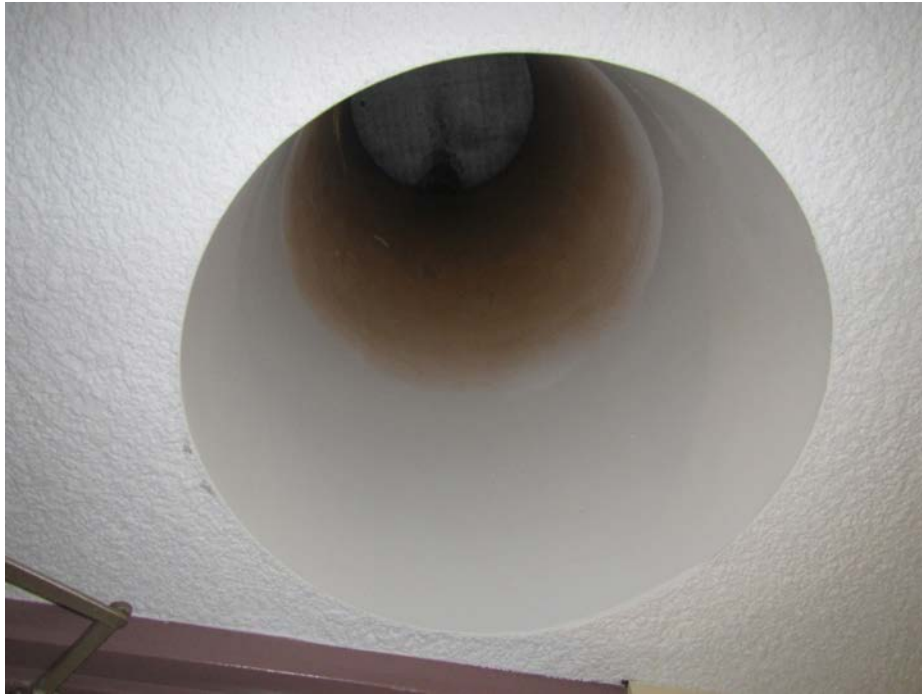
**Picture 9**

**Water stains in skylight**

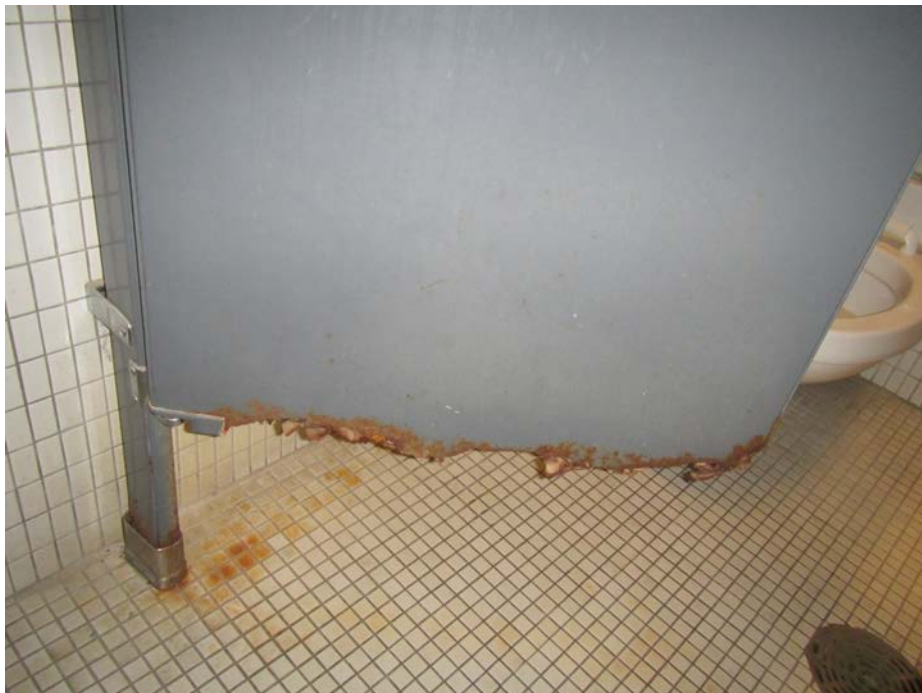
**Picture 10**

**Corroded lower edge of door in men's restroom**

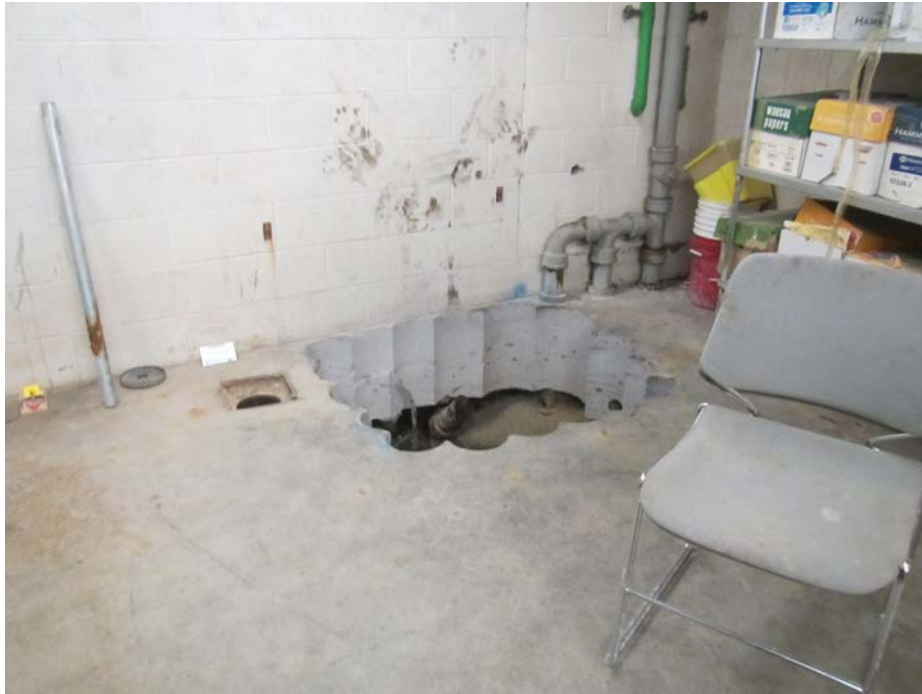
**Picture 11**

Another potential source of odors to the mezzanine may come from the utility/kitchen level below. There are dumpsters stored in this area which collect garbage. A garbage odor was noticeable but not very strong in this area at the time of the assessment. There is also an old grease trap that was reportedly installed at the time of the building construction and not cleaned or otherwise addressed until recently. It will reportedly be a long process of breaking concrete to access and clean the trap (Pictures 11 and 12). This work is typically done on weekends. There was a pile of concrete rubble and other materials next to the trap and the area had an unpleasant odor. Since the grease trap issue is relatively recent, recent issues with odors may be related. Due to the construction and condition of the building, finding and sealing pathways between the

**Site of old grease trap**

utility level and mezzanine may be difficult. Ventilating the utility area to outside mechanically should be performed, and efforts to contain odors from garbage and the grease trap work (e.g., removing waste materials daily, ensuring dumpsters close completely and covering the work area for the grease trap) should be conducted diligently.

6. Avoid storing anything in areas with known leaks and avoid placing porous materials on floors, including area rugs.
7. Ensure that sources of odor in the utility space beneath the mezzanine are controlled, including fitted lids on dumpsters, regular removal of waste, and covers/ventilation for work being performed on the grease trap. If further

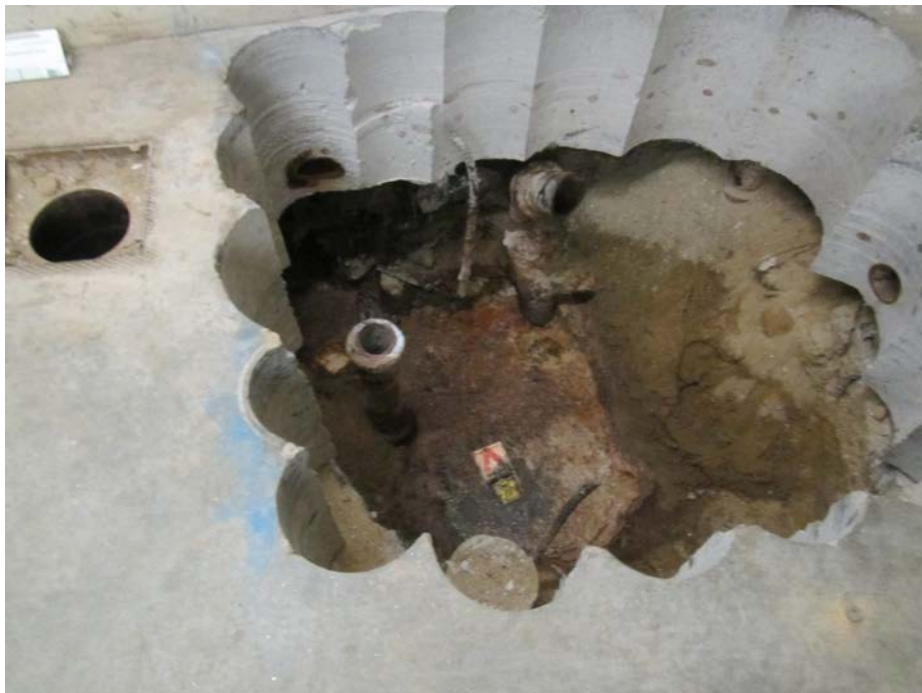
**Picture 12**

**Surface of old grease trap**

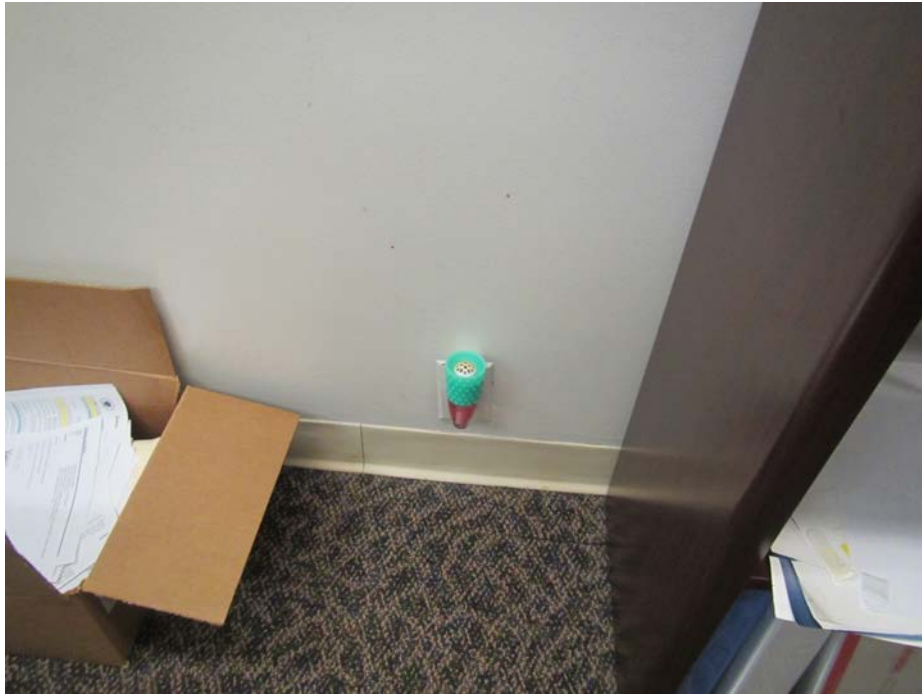
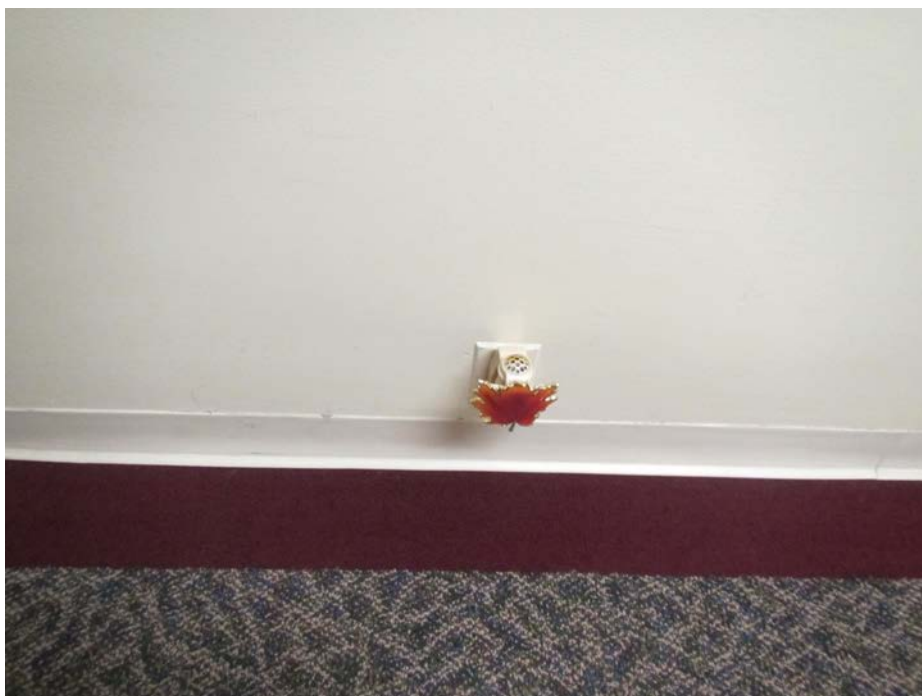
Note that in an effort to deal with the odors, staff in the mezzanine had acquired numerous plug-in type air fresheners for use in offices and common areas (Pictures 13 and 14). The BEH IAQ program does not recommend the use of scented products as they emit volatile organic compounds (VOCs) and fragrances. Exposure to low levels of total volatile organic compounds (TVOCs) may produce eye, nose, throat, and/or respiratory irritation in some sensitive individuals. Fragrances can be a source of irritation or allergic reaction. These products do not remove odors, but cover them up with another scent. Finding and removing the sources of odors is more effective.

**Plug-in air freshener**

11. Keep plants in good condition, avoid overwatering, and remove from the airstream of heating and ventilation equipment.
12. Reduce the use of cleaning products, sanitizers, and other items that contain VOCs. Minimize the use of scented products.

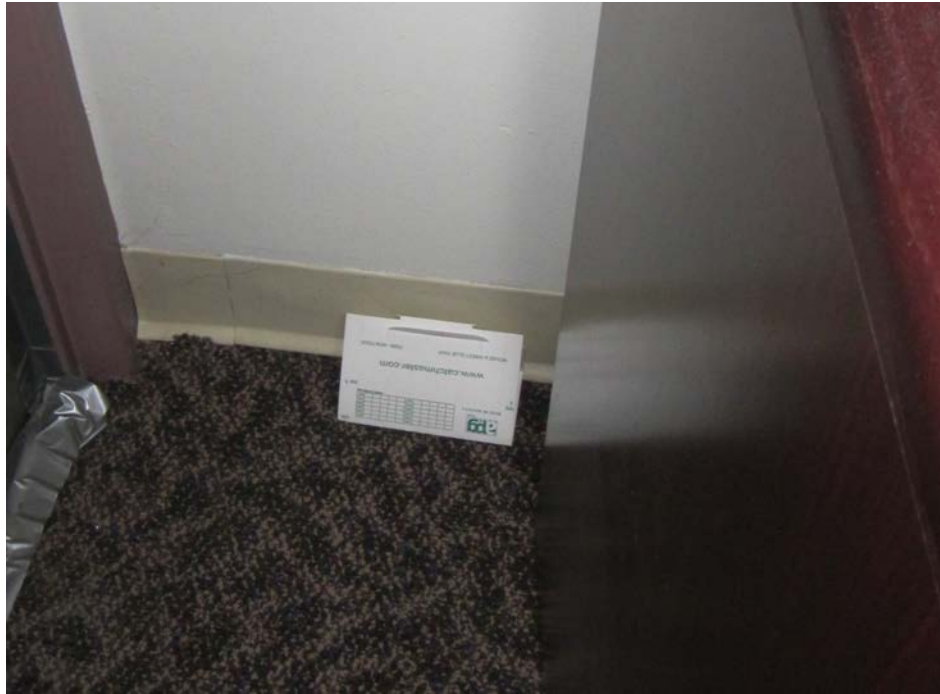
**Picture 15**

Cooking equipment, including toasters, microwave ovens, and coffee machines, were located in various parts of the office space. Food areas and cooking equipment need to be kept clean to prevent odors and pests. Mice are an occasional problem in this office, and rodent traps were observed in a few areas (Picture 15). Excluding mice from the building is difficult, so occupants must make sure that conditions that attract mice are minimized by sealing food in mouse-proof containers, cleaning crumbs and preventing conditions that may be used as harborage (e.g., boxes of paper on the floor). If rodent problems persist, a licensed pest contractor should be consulted.

**Mousetrap in an office**
